SUBJ: EPA Asbestos Removal at 214 Depot Street

REMOVAL ACTION STATUS REPORT DAVIDSON ASBESTOS

Property Address: 214 Depot Street, Davidson, Mecklenburg County, North Carolina

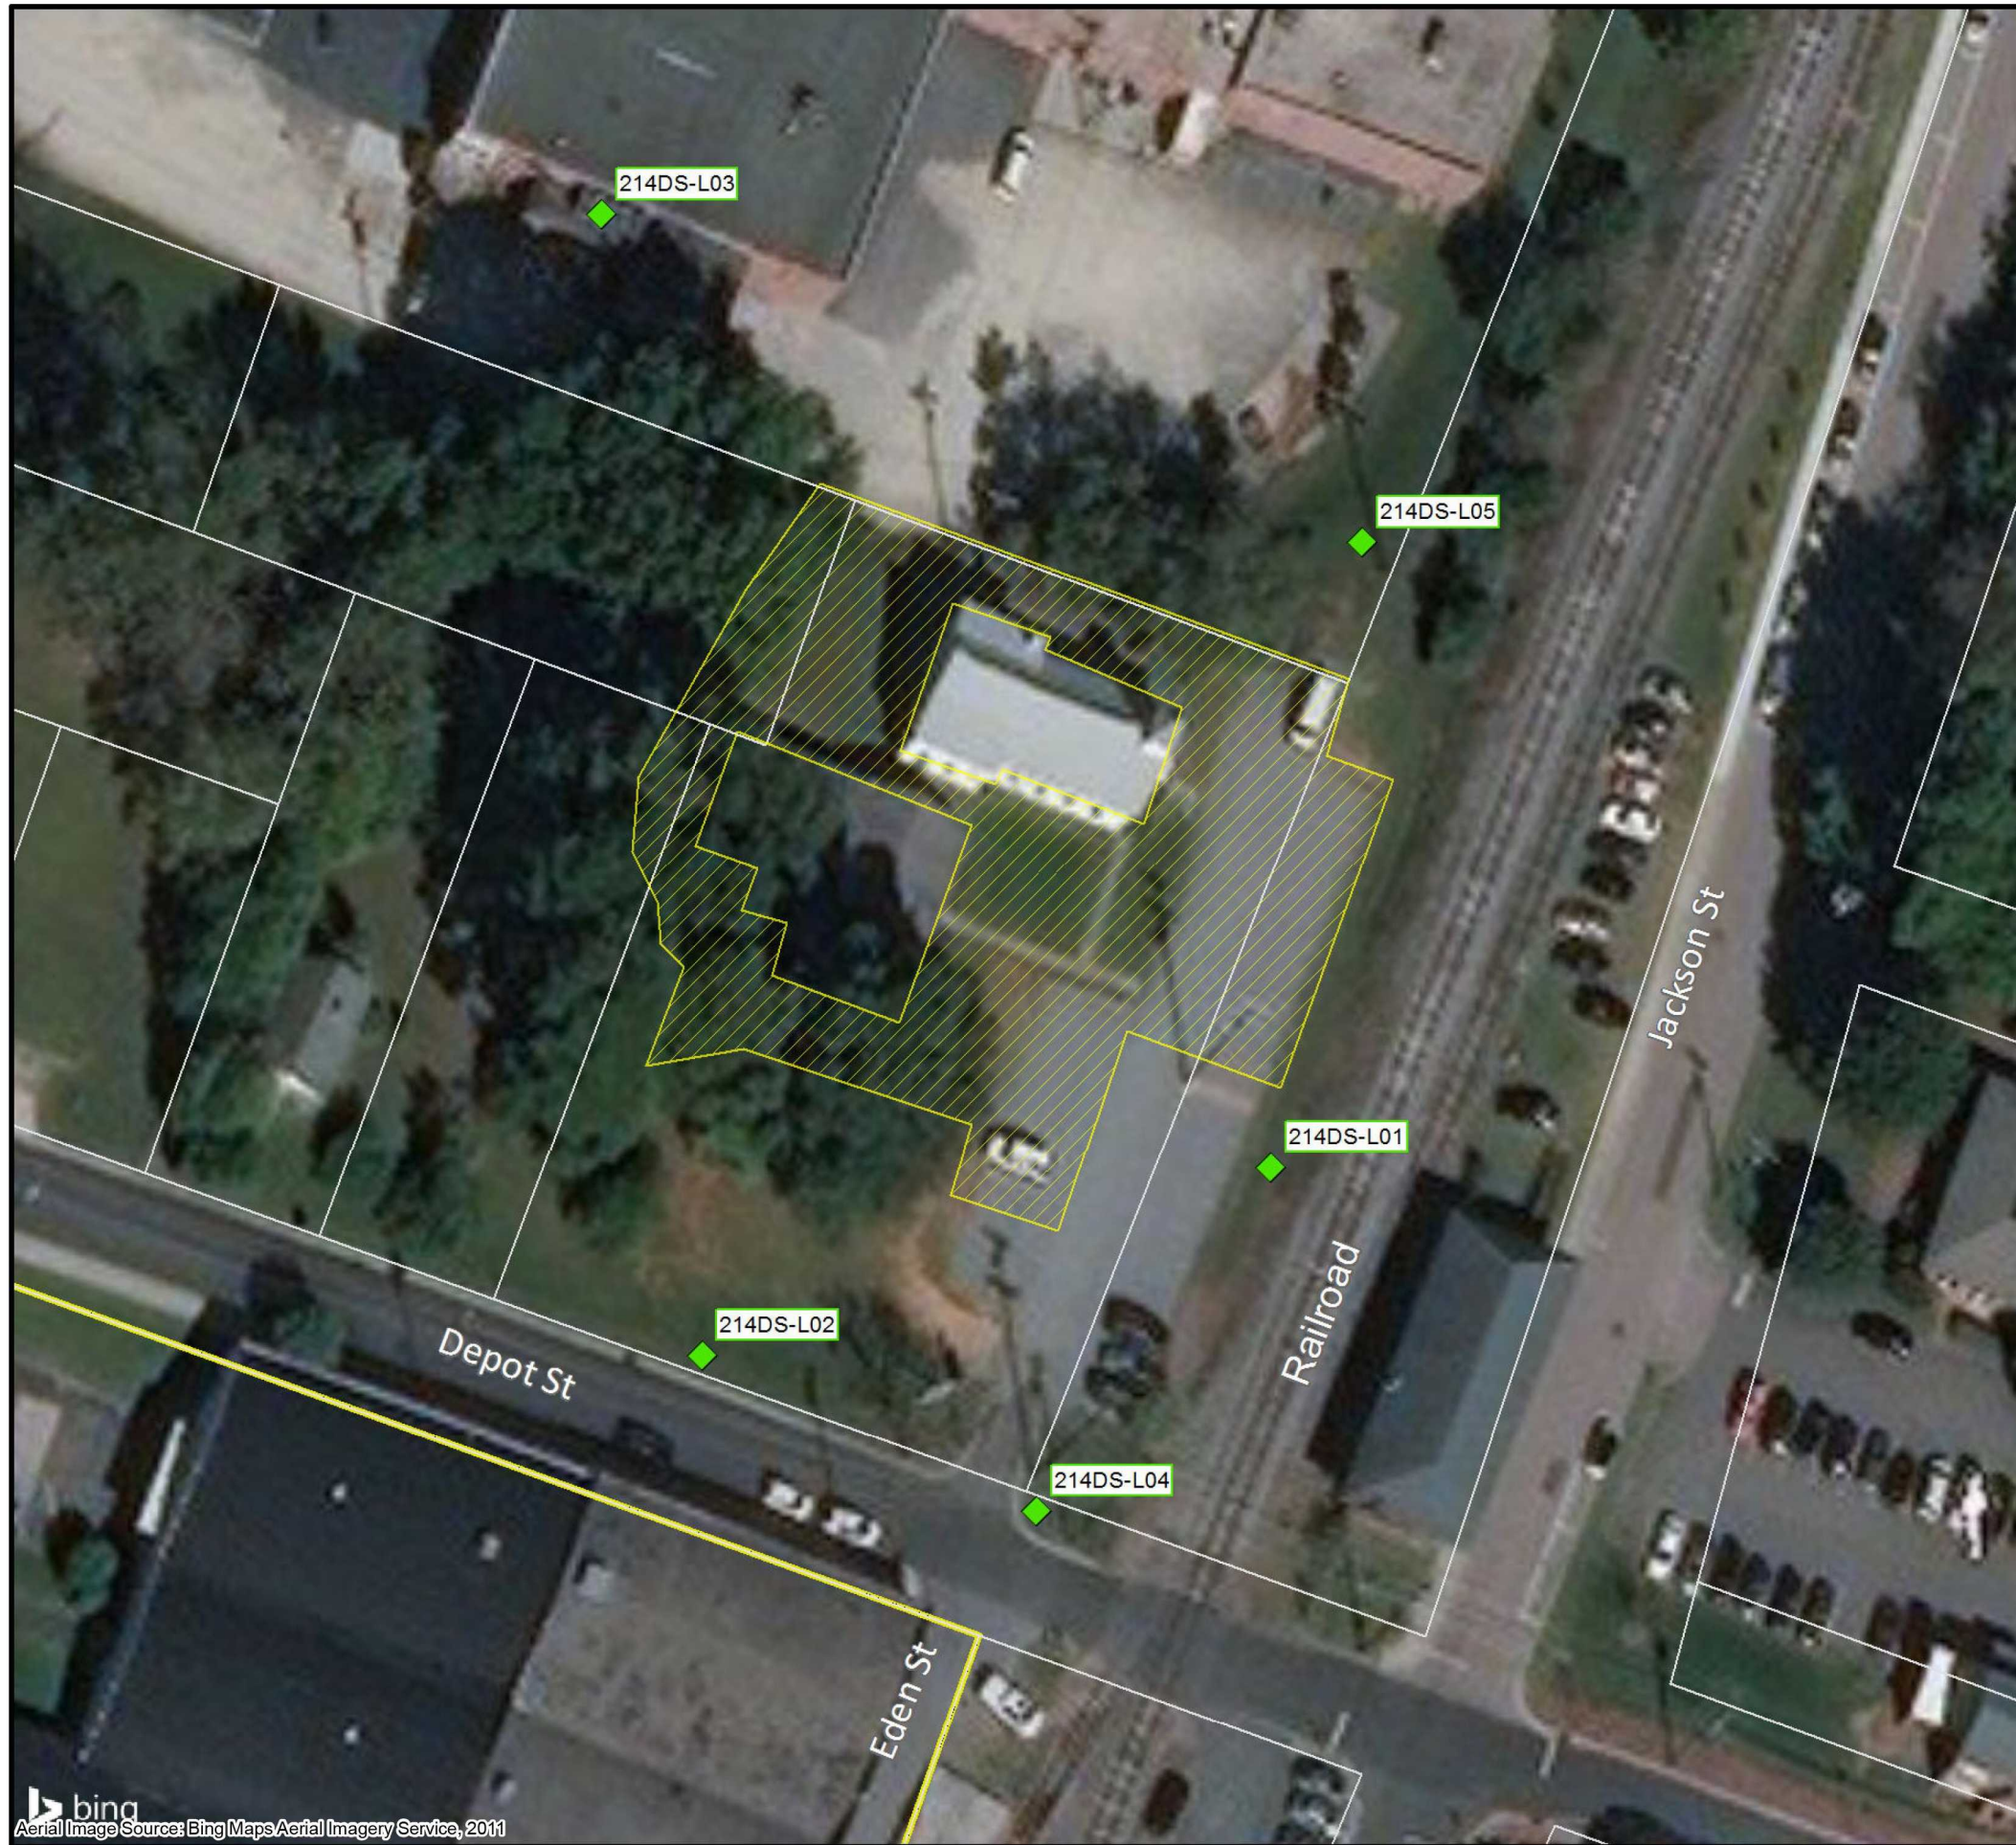
FIGURE 1

Description of Removal Action: The soil was excavated to an approximate maximum depth in the following areas: lawn to 18 inches; parking lot to 24 inches; and tree line and building drip line areas to 3 inches (See Appendix 1). Visual inspections of the excavated areas for asbestos-containing materials (ACM) were conducted by a State of North Carolina-accredited asbestos inspector and air monitor. Additional removal was conducted in those areas where ACM were still visibly present. Once ACM was no longer visibly present, restoration of the excavated areas was allowed to commence.

Removal Areas and
Air Sampling Locations

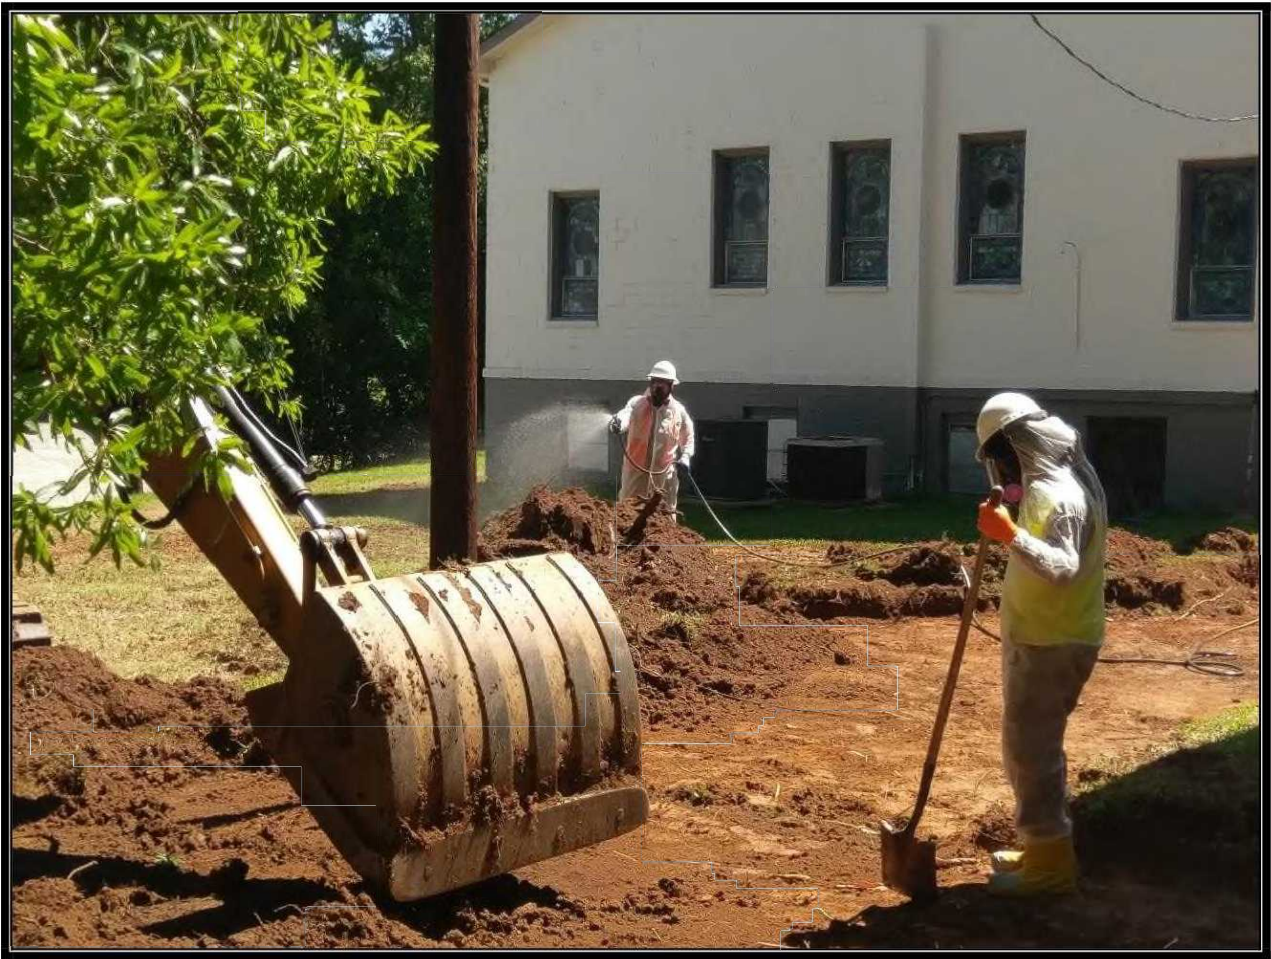
OFFICIAL PHOTOGRAPH NO. 1
U.S. ENVIRONMENTAL PROTECTION AGENCY

Subject: The Emergency and Rapid Response Services (ERRS) contractor, Environmental Restoration, LLC (ER), used an excavator and hand tools to remove asbestos-containing materials (ACM) and asbestos-contaminated soil from the property located at 214 Depot Street. ER used hoses to wet the asbestos-contaminated soil during removal activities.

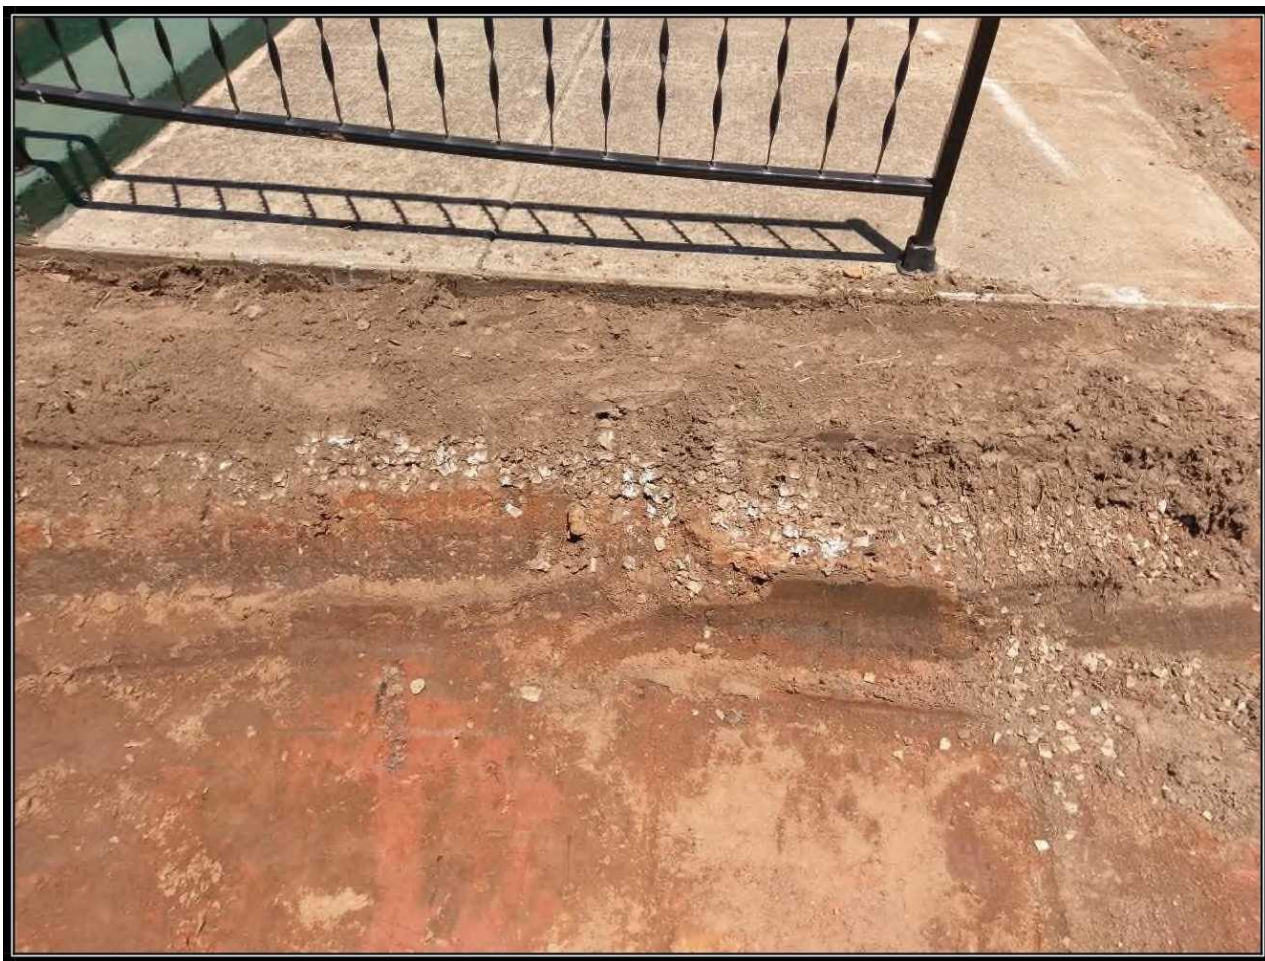
OFFICIAL PHOTOGRAPH NO. 2
U.S. ENVIRONMENTAL PROTECTION AGENCY

Subject: A Tetra Tech Superfund Technical Assessment and Response Team (START), State of North Carolina-accredited asbestos inspector and air monitor inspected the excavated areas for the presence of visible ACM. ER removed additional soil in areas where ACM was visible.

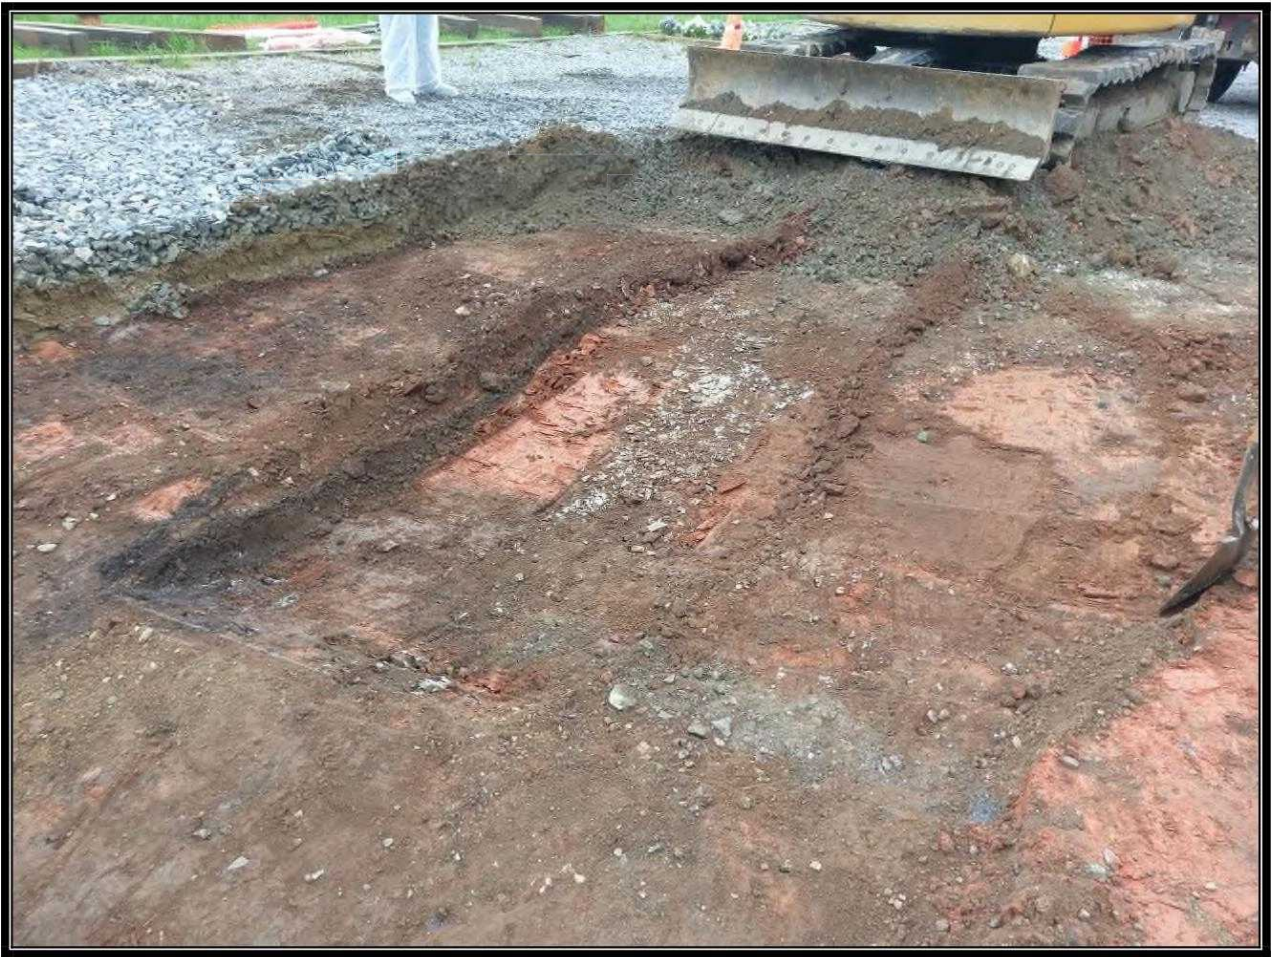
OFFICIAL PHOTOGRAPH NO. 3
U.S. ENVIRONMENTAL PROTECTION AGENCY

TDD Number:	TT-01-071	Location:	Davidson Asbestos
Orientation:	Not applicable	Date:	May 24, 2017
Photographer:	Paul Prys, Tetra Tech	Witness:	None
Subject:	Tetra Tech START, State of North Carolina-accredited asbestos inspector and air monitor inspected the excavated areas for the presence of visible ACM. ER removed additional soil in areas where ACM was visible.

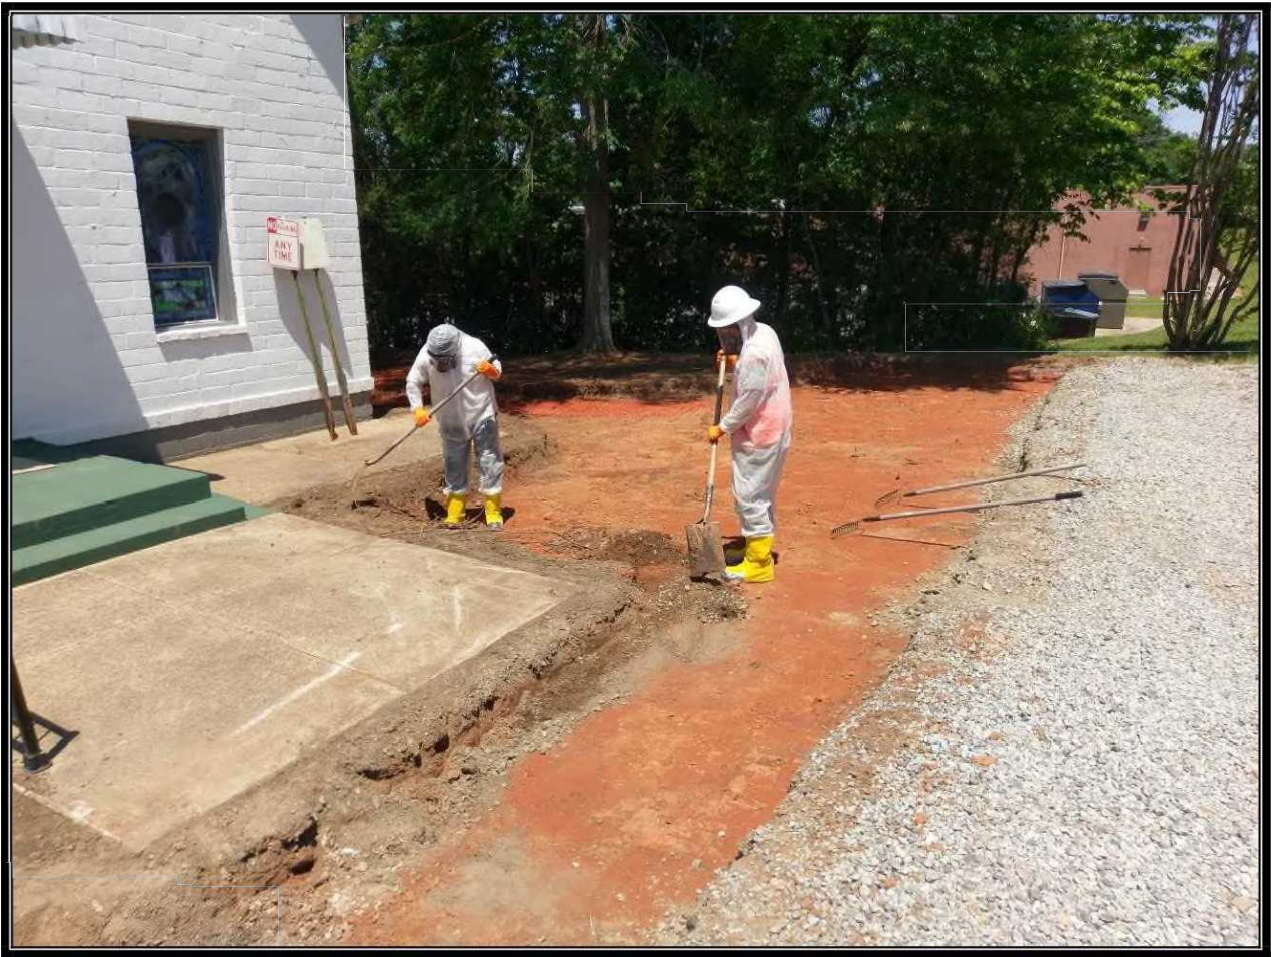
OFFICIAL PHOTOGRAPH NO. 4
U.S. ENVIRONMENTAL PROTECTION AGENCY

Subject: ER removed additional visible ACM and associated asbestos-contaminated soil using an excavator and hand tools.

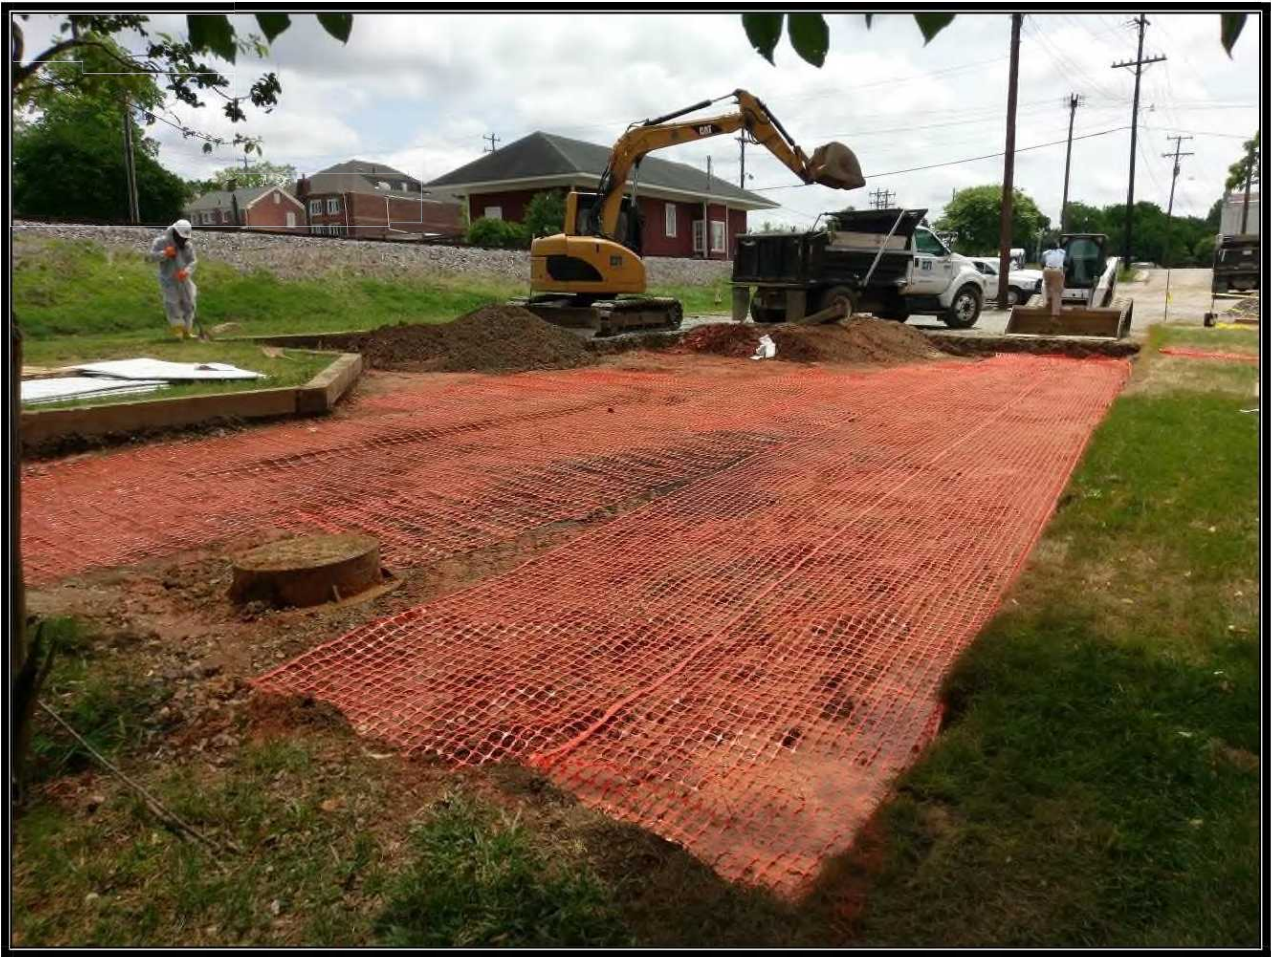
OFFICIAL PHOTOGRAPH NO. 5
U.S. ENVIRONMENTAL PROTECTION AGENCY

Subject: ER installed snow fencing along the subsurface of the excavated area after the visual inspection conducted by Tetra Tech START, State of North Carolina-accredited asbestos inspector and air monitor detected no visible ACM in the excavated area.

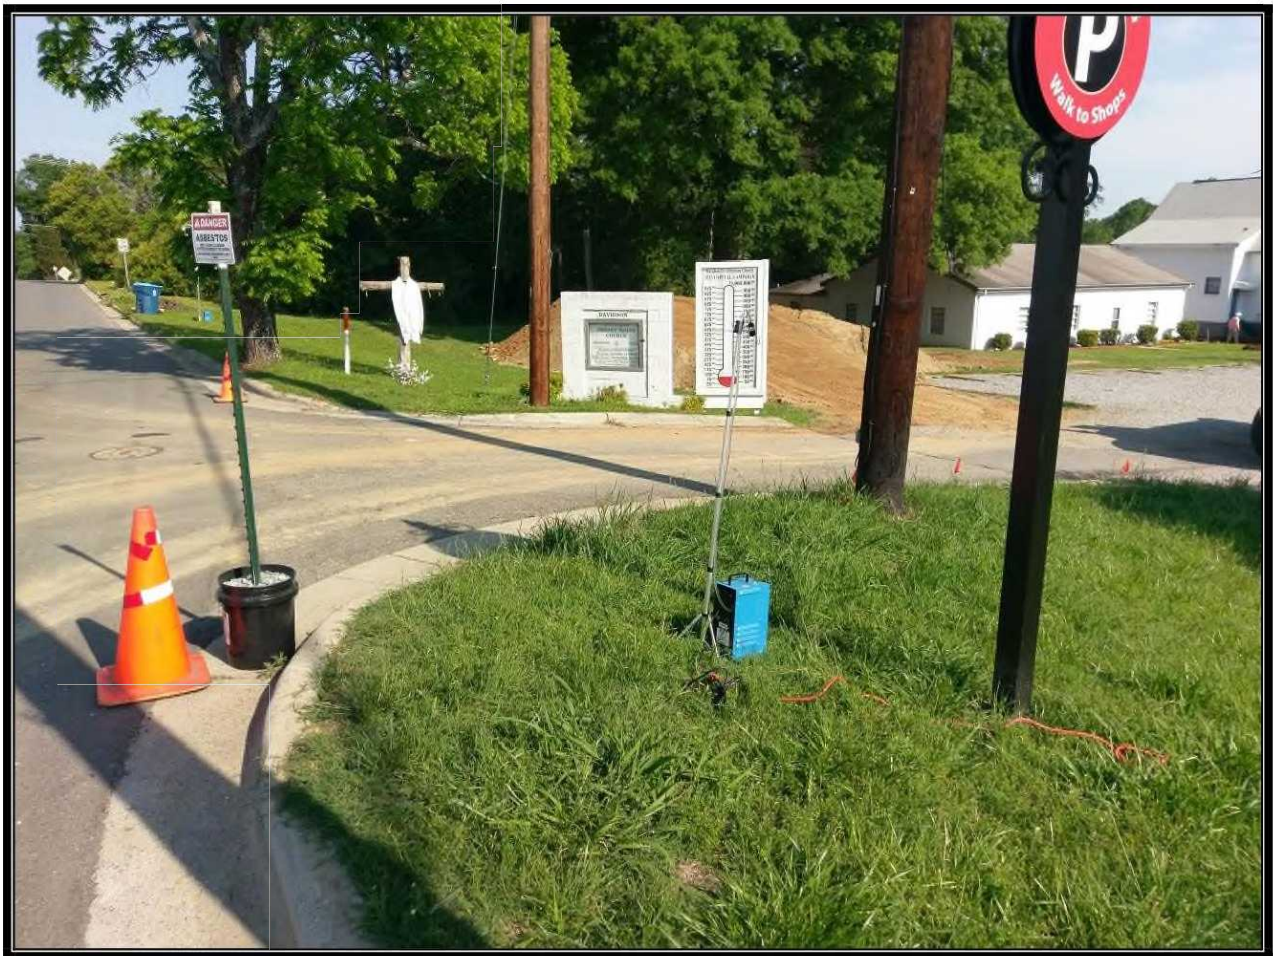
OFFICIAL PHOTOGRAPH NO. 6
U.S. ENVIRONMENTAL PROTECTION AGENCY

Subject: Perimeter air sampling was conducted by a Tetra Tech START, State of North Carolina-accredited air monitor to evaluate the effectiveness of engineering and safety controls in preventing off-site migration of asbestos fibers during removal activities.

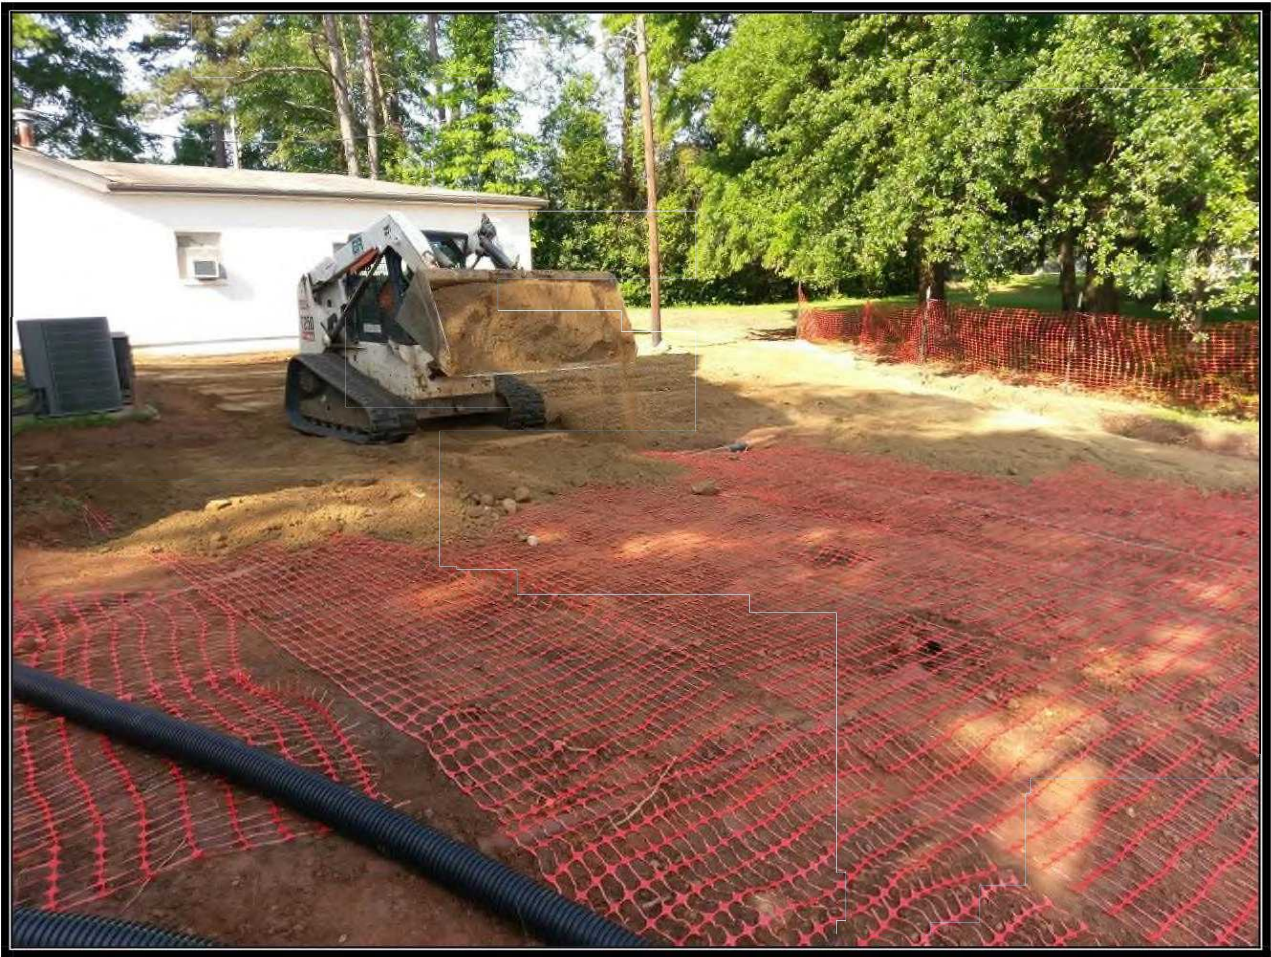
OFFICIAL PHOTOGRAPH NO. 7
U.S. ENVIRONMENTAL PROTECTION AGENCY

Subject: ER used dump trucks and skid steers to install backfill in the excavated areas.

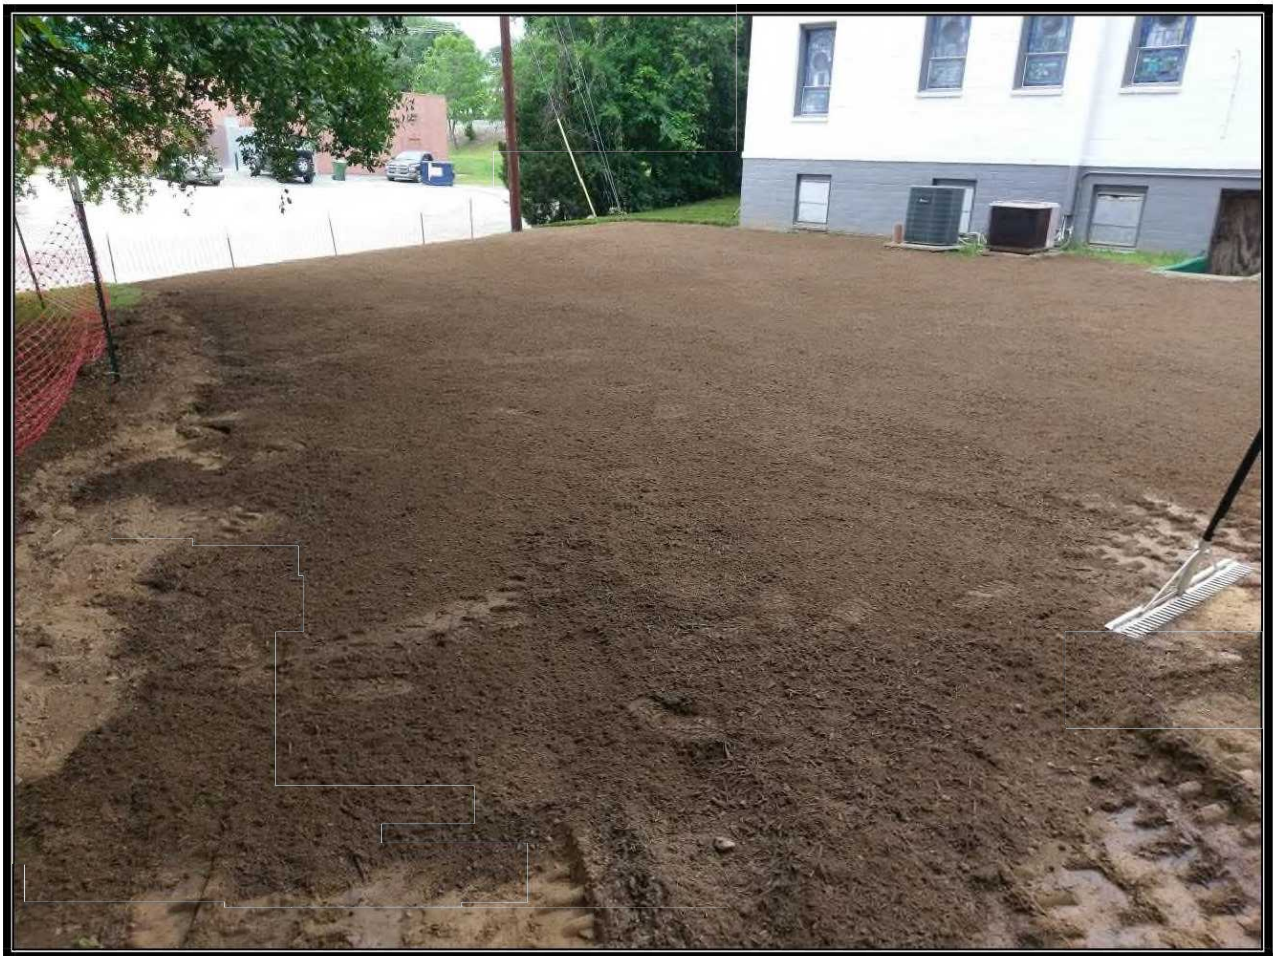
OFFICIAL PHOTOGRAPH NO. 8
U.S. ENVIRONMENTAL PROTECTION AGENCY

TDD Number: TT-01-071 **Location:** Davidson Asbestos
Orientation: Northeast **Date:** May 12, 2017
Photographer: Paul Prys, Tetra Tech **Witness:** None
Subject: ER used dump trucks, skid steers, and rakes to install topsoil in the excavated areas.

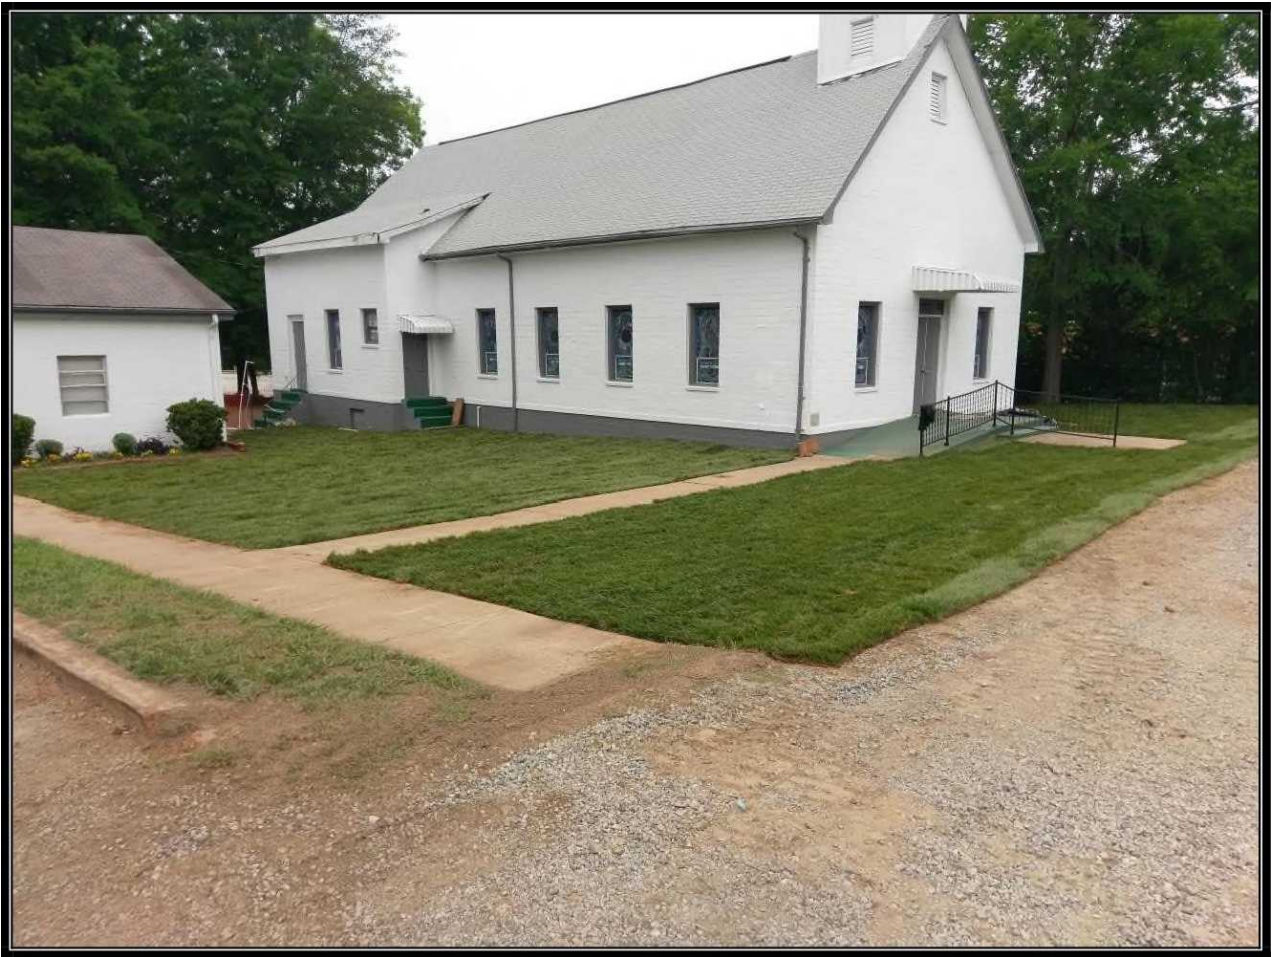
OFFICIAL PHOTOGRAPH NO. 9
U.S. ENVIRONMENTAL PROTECTION AGENCY

Subject: ER installed sod in the excavated areas after backfill and topsoil were in place.

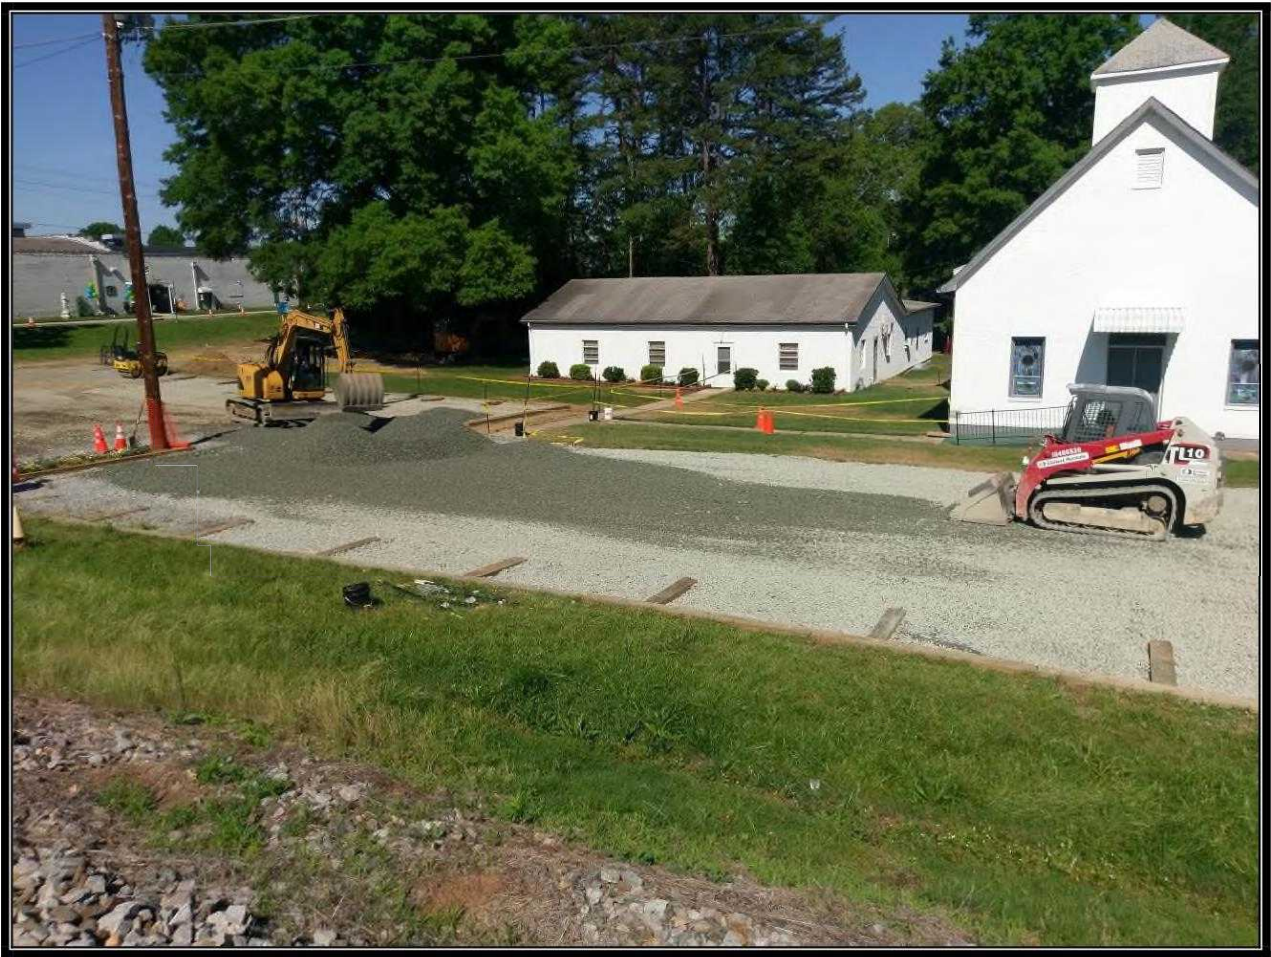
OFFICIAL PHOTOGRAPH NO. 10
U.S. ENVIRONMENTAL PROTECTION AGENCY

Subject: ER installed two layers of rock in the excavated parking lot after backfill was installed.

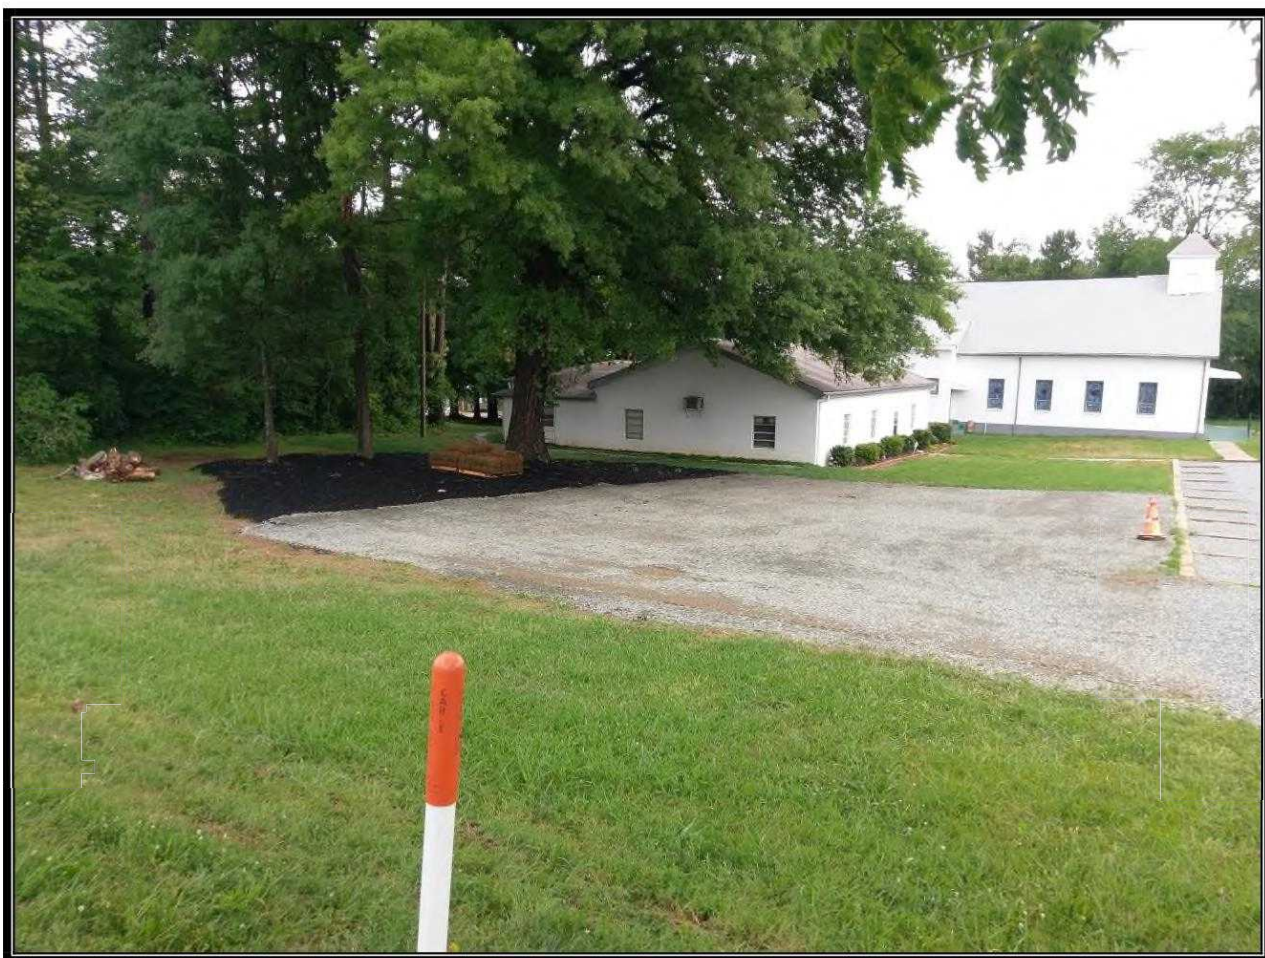
OFFICIAL PHOTOGRAPH NO. 11
U.S. ENVIRONMENTAL PROTECTION AGENCY

Subject: ER installed mulch under the tree line areas that had been surface scraped after topsoil was installed.

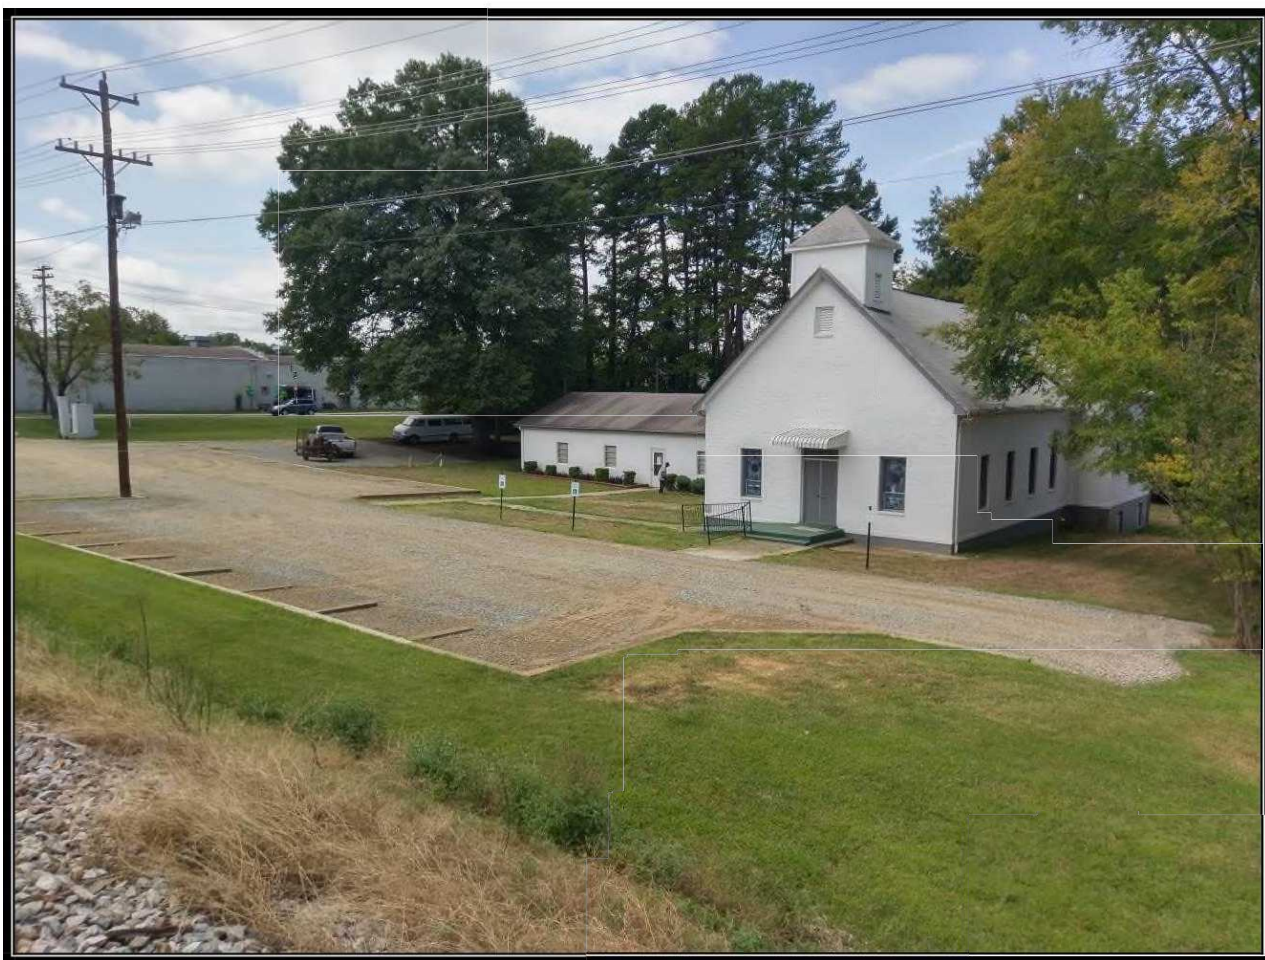
OFFICIAL PHOTOGRAPH NO. 12
U.S. ENVIRONMENTAL PROTECTION AGENCY

Subject: ER installed additional rock to the parking lot area before ER demobilized from the site.
